NDI ID PA 00791

SILVER LAKE DAM

PHASE I INSPECTION REPORT
NATIONAL DAM INSPECTION PROGRAM

APRIL 1981

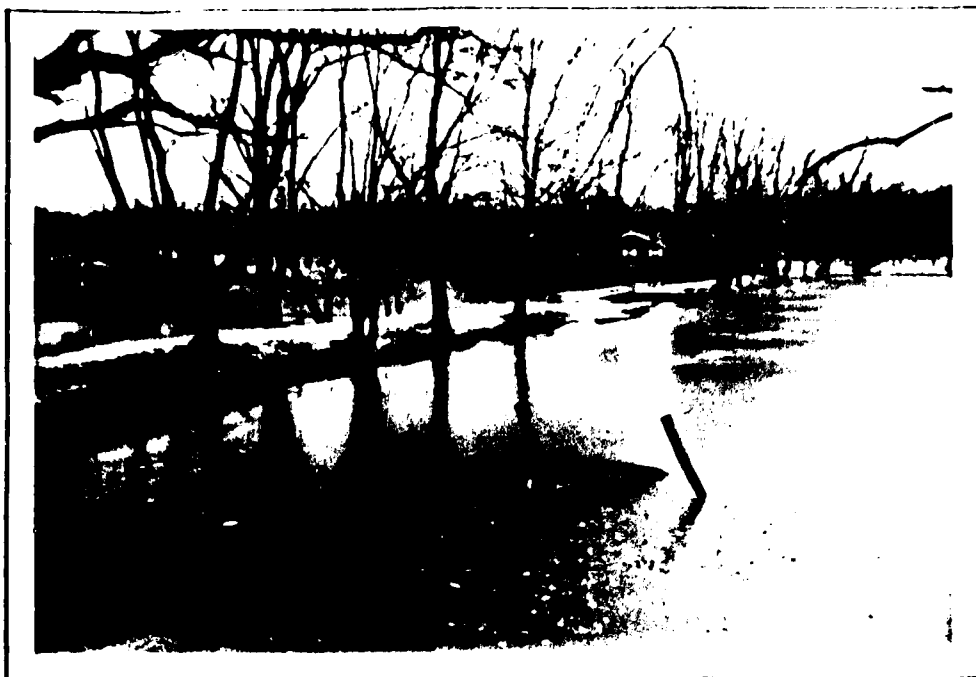
UPSTREAM OVERVIEW OF SILVER LAKE DAM FROM THE LEFT
ABUTMENT. (12/17/80)

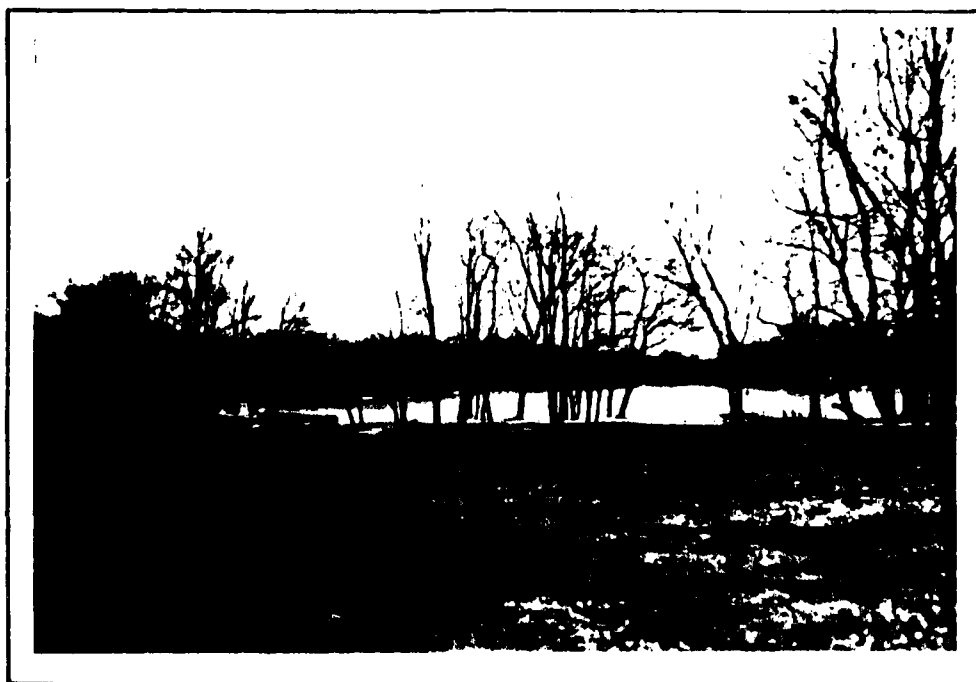
DOWNSTREAM OVERVIEW OF SILVER LAKE DAM FROM THE LEFT
ABUTMENT (12/17/80)

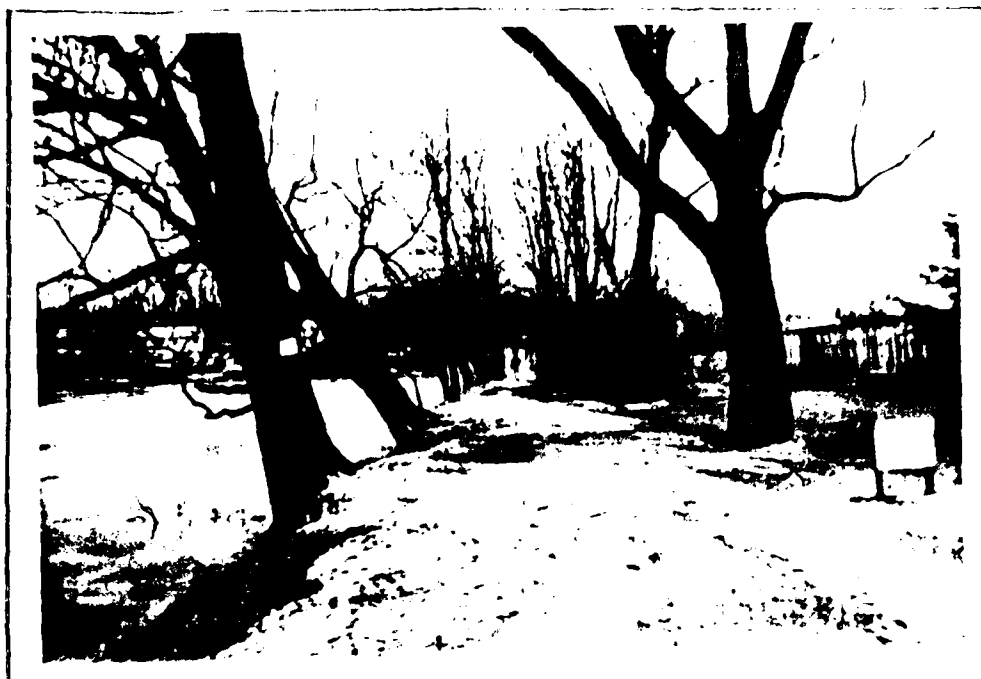
1. VIEW ALONG CENTERLINE OF DAM FROM THE RIGHT ABUTMENT.
(12/17/80)

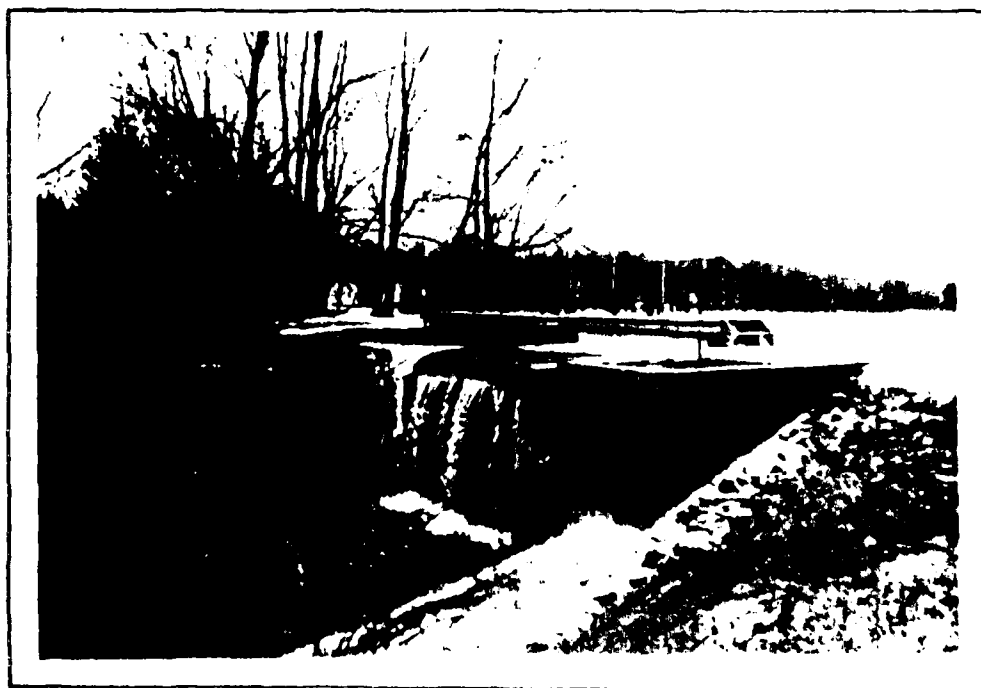
c. Appurtenant Structures. The spillway structure appears to be in good condition. No misalignment was evident in the structure. The exposed concrete surfaces are in good condition. The masonry sidewalls are constructed with relatively large stones. No evidence of joint material deterioration was noted. No seepage through the structure was noted.

The gate chamber structure located immediately to the left of the spillway appears to be in good condition. No spalling or scaling of the concrete was noted. No seepage around the base of the structure was detected.

The overflow waterway is located immediately to the left of the gate chamber structure. The portion of this waterway constructed on the embankment crest is lined with concrete, while the portion constructed on the downstream face of the embankment is lined with grouted riprap. The structure appears to be in good condition. No cracking, settlement or displacement was noted in the concrete or grouted riprap linings.

2. SPILLWAY, CONCRETE BOX OF OUTLET PIPES AND OVERFLOW
WATERWAY IN FOREGROUND. (12/17/80)

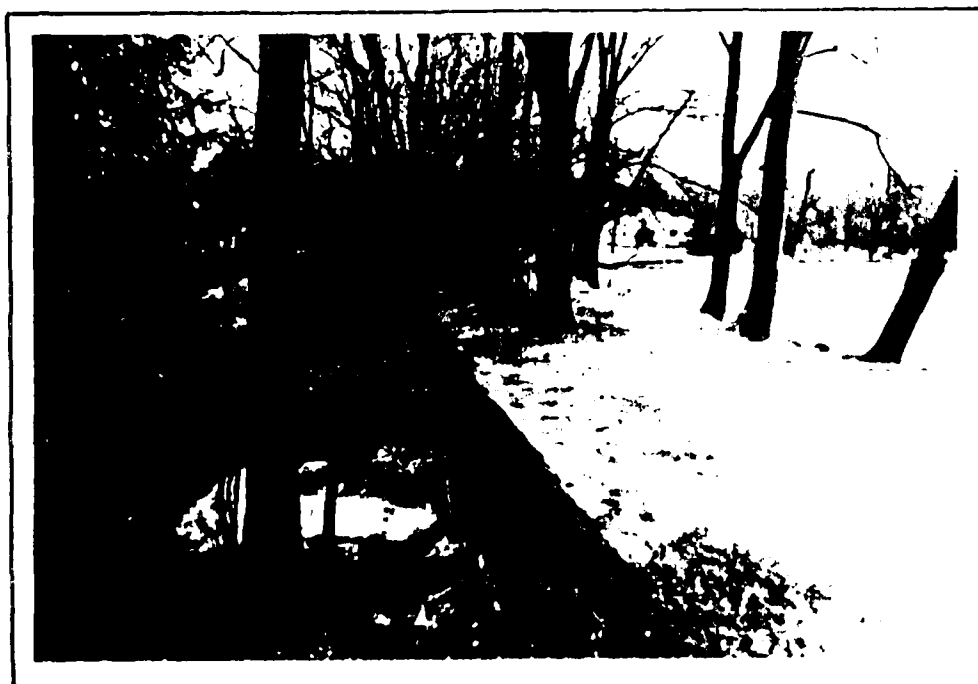
4 VIEW ALONG THE TOP OF DAM FROM THE RIGHT SIDEWALK OF THE SPILLWAY. (12/17/80)

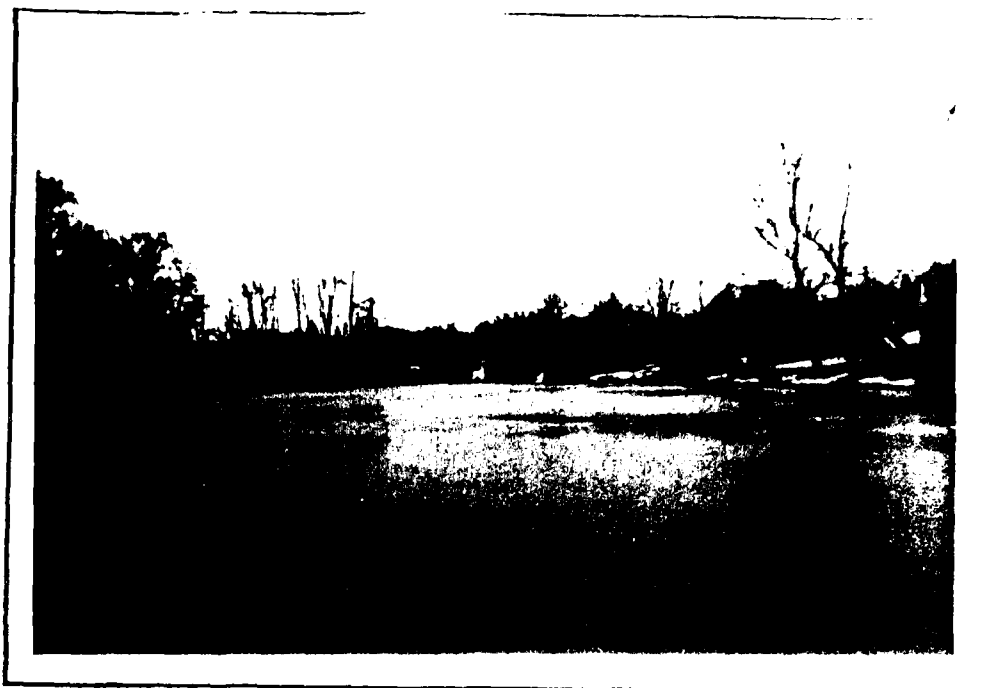
7. SILVER LAKE DAM VIEWED FROM THE DAM FOR THE DOWNSTREAM POND. (12/17/80)

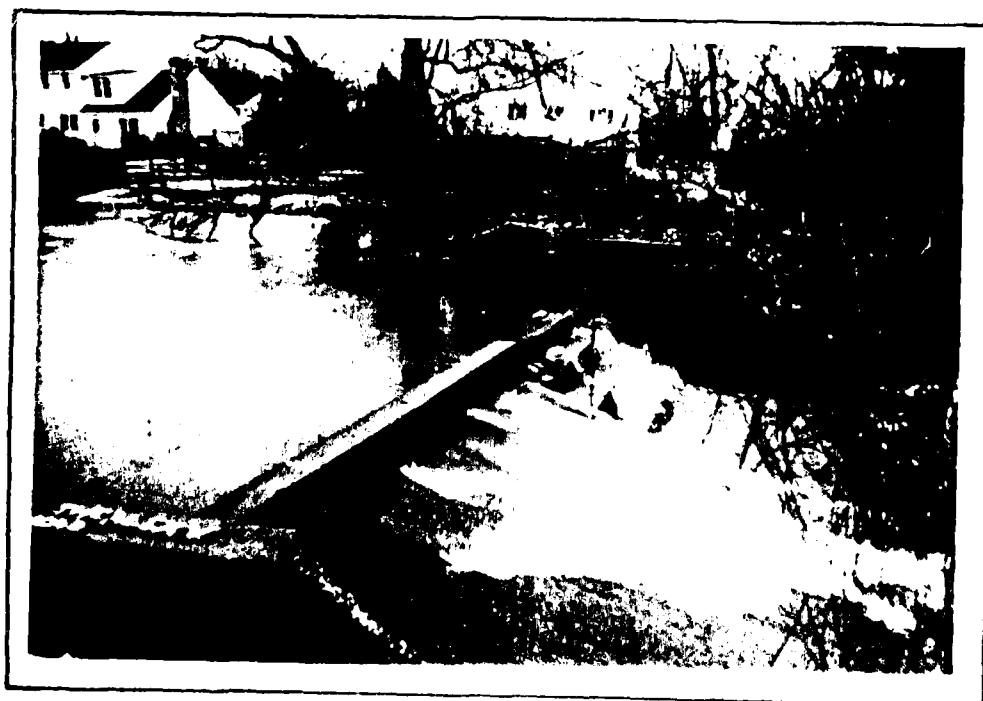
8. SPILLWAY FOR THE DOWNSTREAM POND. (12/17/80)

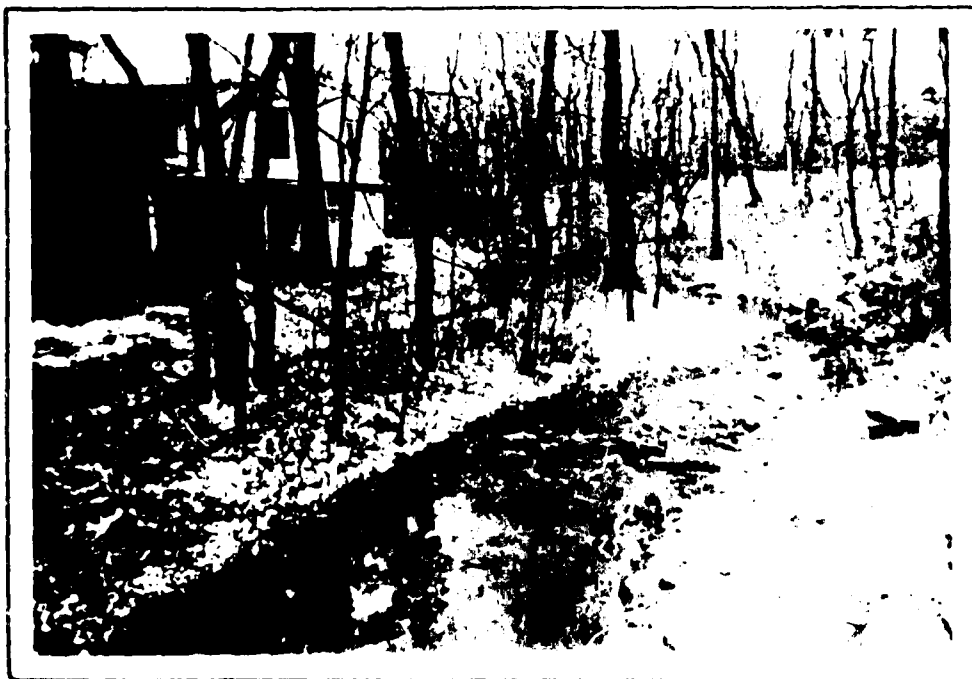
10 INITIAL POTENTIAL HAZARD AREA ABOUT 3,500 FEET DOWNSTREAM
FROM THE DAM. (12/17/80)

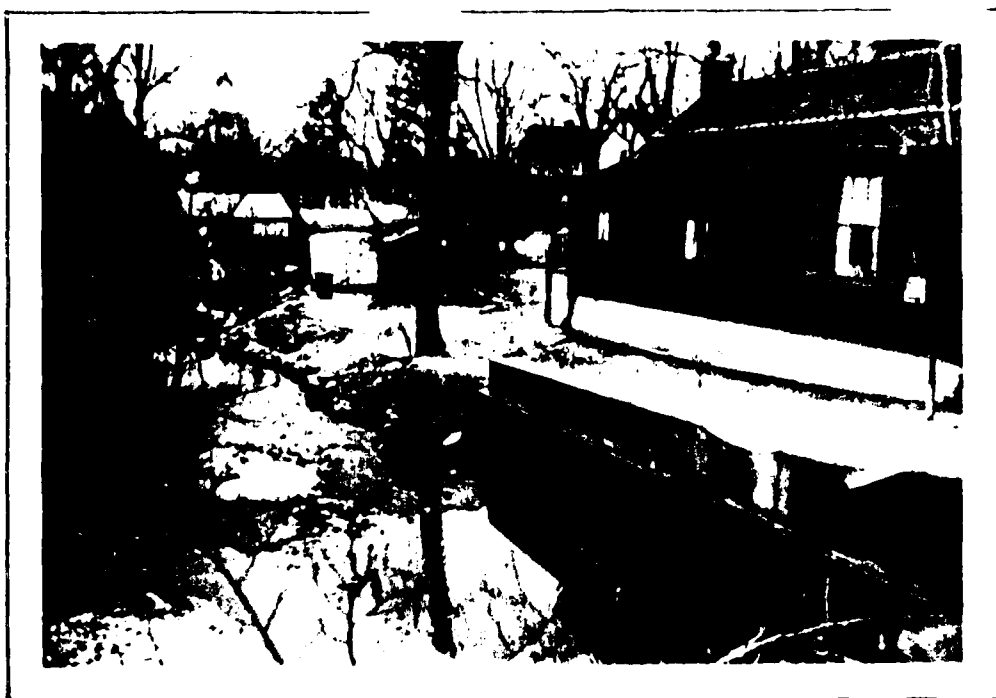
Three inhabited houses are located in close proximity to Van Horn Creek about 3,500 feet downstream of Silver Lake Dam. The floor elevation of the lowest house is approximately five feet above the streambed. Because of the potential for the possible loss of a few lives and appreciable property damage in the hazard area, Silver Lake Dam is classified as "Significant" hazard structure.

11. POTENTIAL HAZARD AREA ABOUT 3,500 FEET DOWNSTREAM FROM THE DAM. (12/17/80)

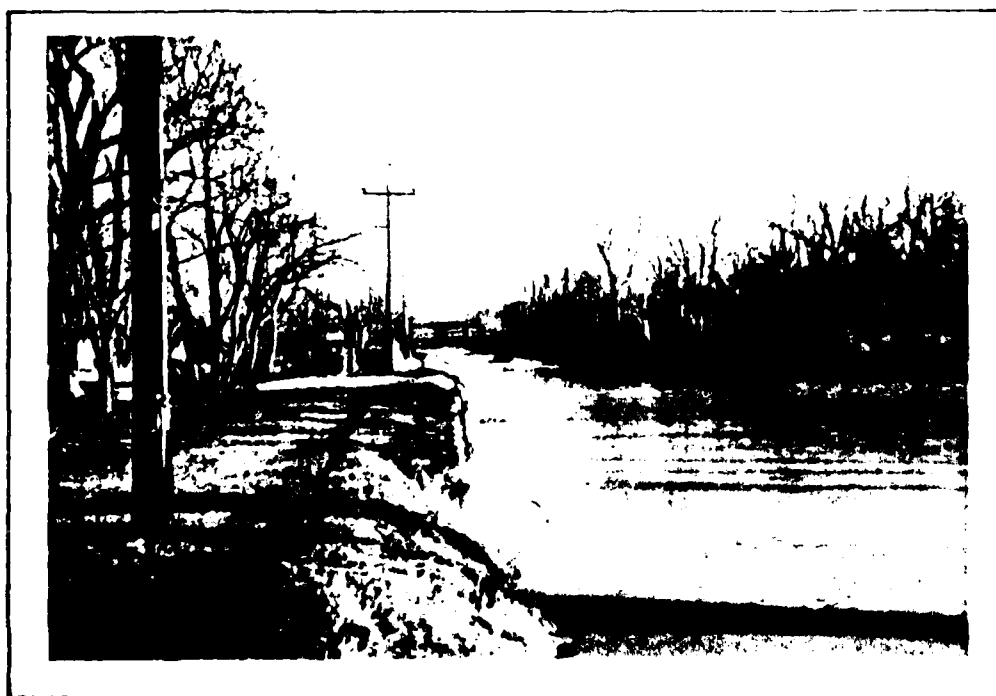
12. DELAWARE CANAL WHERE VAN HOUT CREEK DISCHARGES INTO IT 3,900 FEET DOWNSTREAM FROM THE DAM. (12/17/80)
